**AFFDL-TR-78-175**  
**Volume III**

**EFFECT OF MULTIAXIAL LOADING  
ON CRACK GROWTH  
Volume III - Compilation of Interferometry Photographs**

*NORTHROP CORPORATION  
AIRCRAFT GROUP  
HAWTHORNE, CALIFORNIA 90250*

*December 1978*

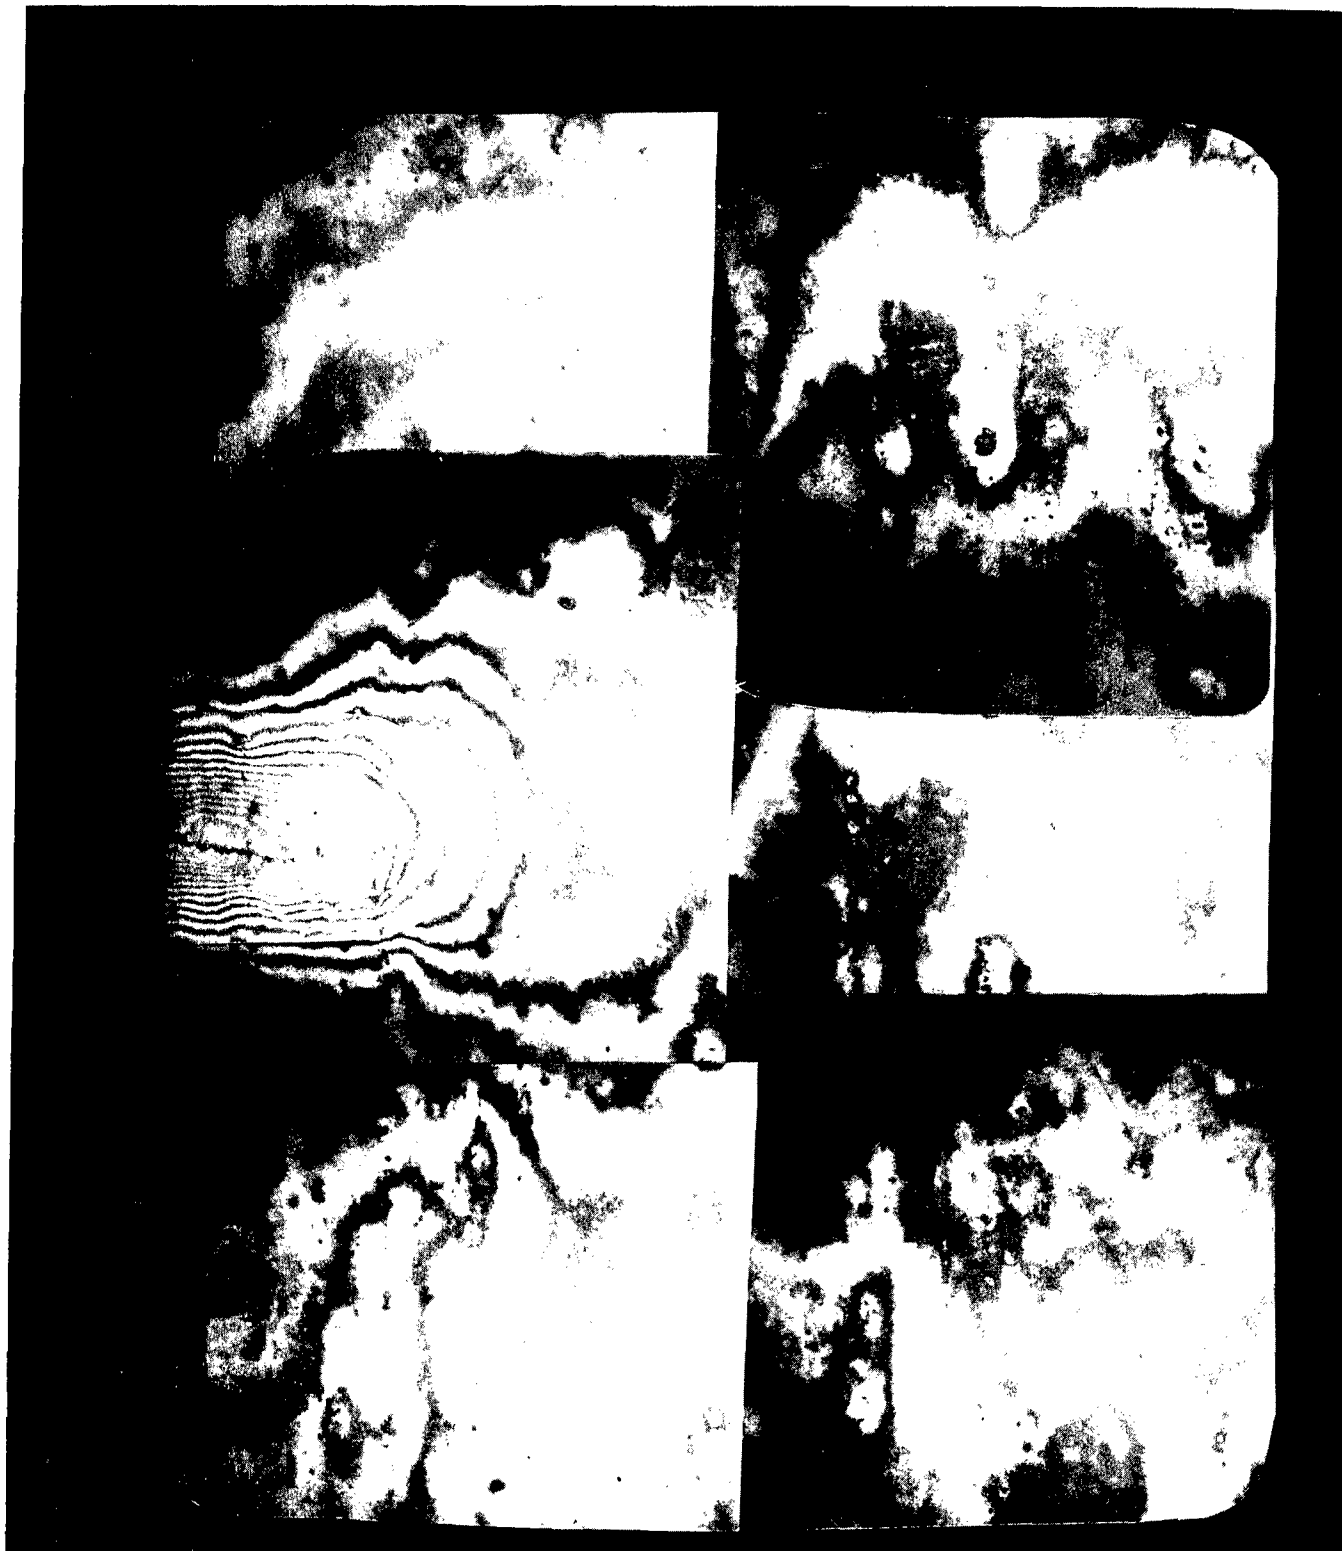
Figure 107. Interferometry Photograph of an Unloaded Crack in a 7075-T7351 Specimen

7075-T7351,  $a = 0.50$  inch  
 $\sigma_x = -6.0$ ,  $\sigma_y = 12$  ksi unloaded  
Magnification: 47.6X  
Test Case 105  
Specimen 7-53-3.1

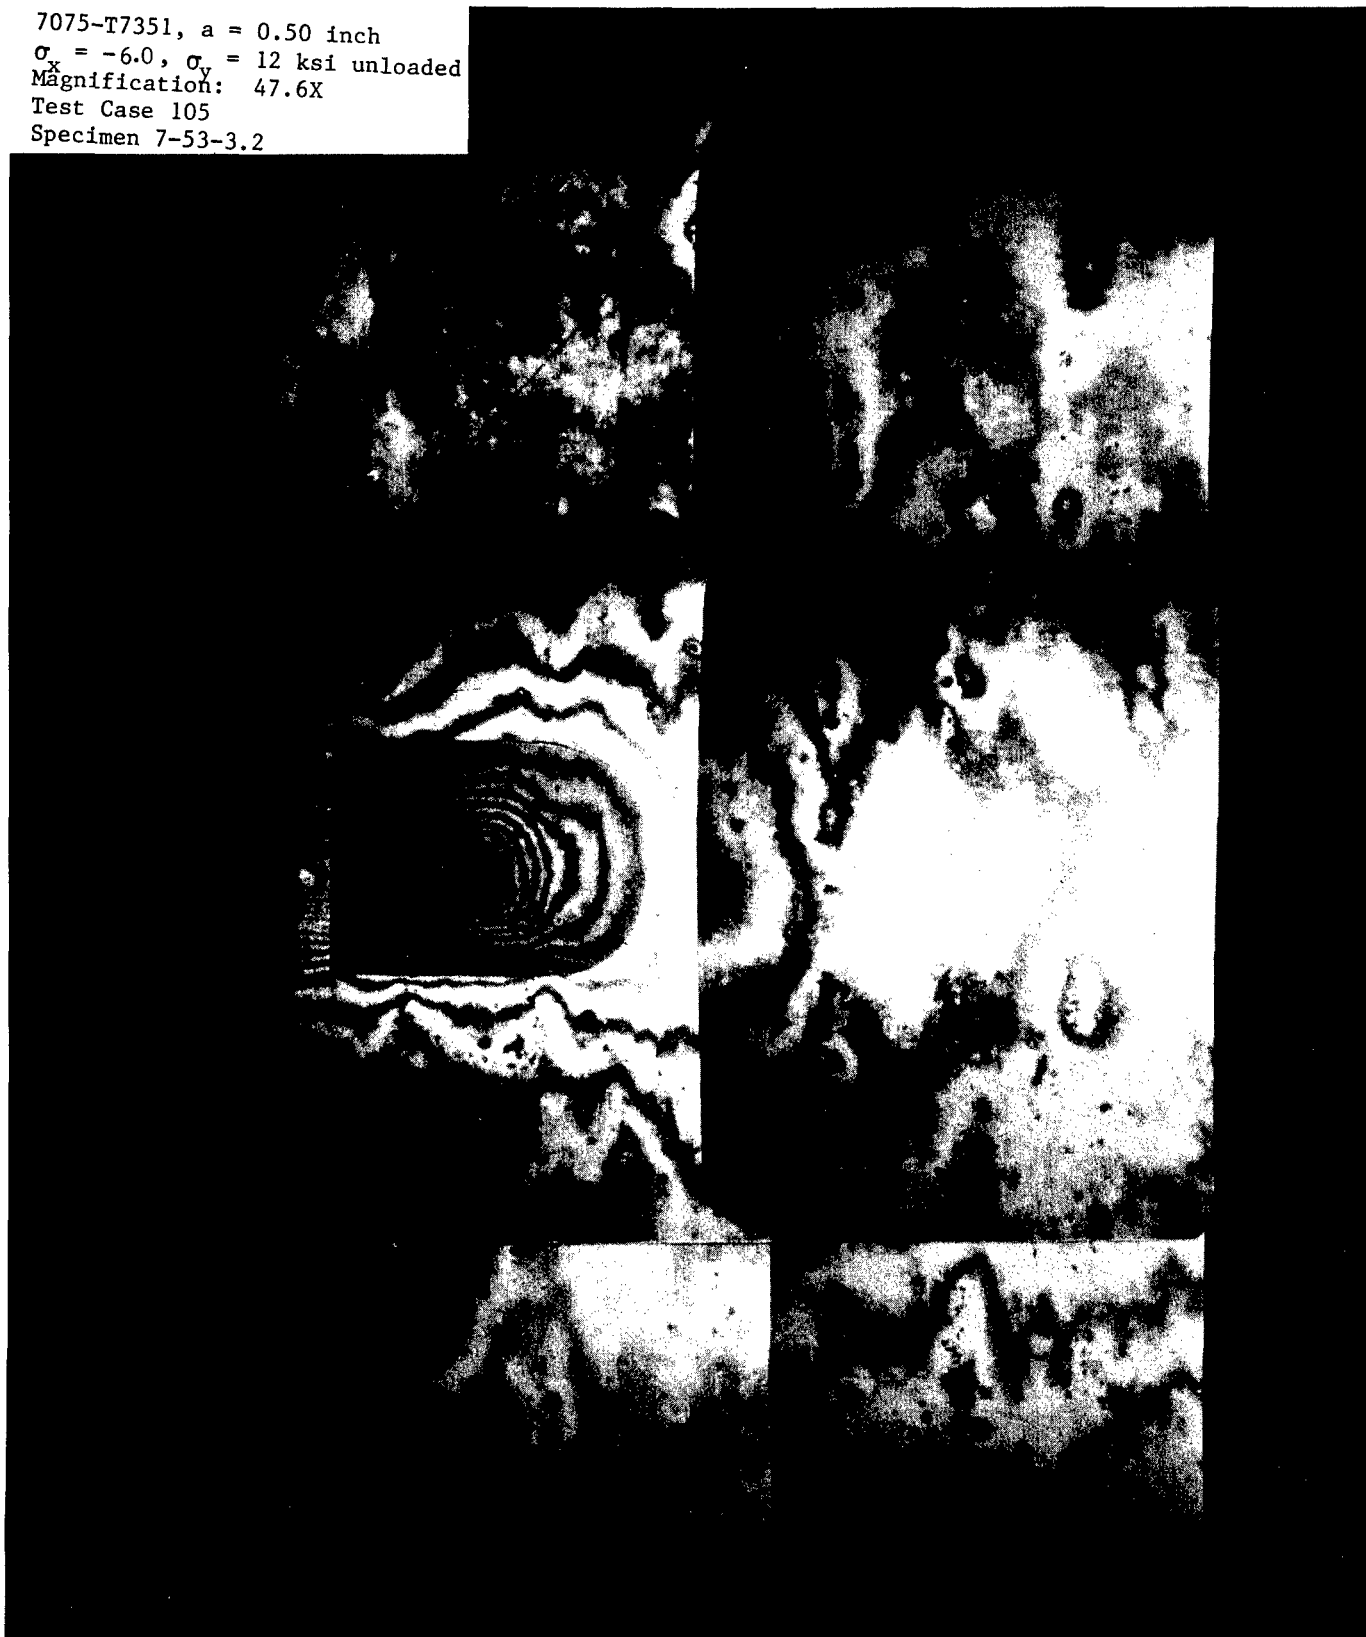
Figure 108. Interferometry Photograph of an Unloaded Crack in a  
7075-T7351 Specimen

7075-T7351,  $a = 0.50$  inch  
 $\sigma_x = -6.0$ ,  $\sigma_y = 12$  ksi unloaded  
Magnification: 47.6X  
Test Case 105  
Specimen 7-53-3.2

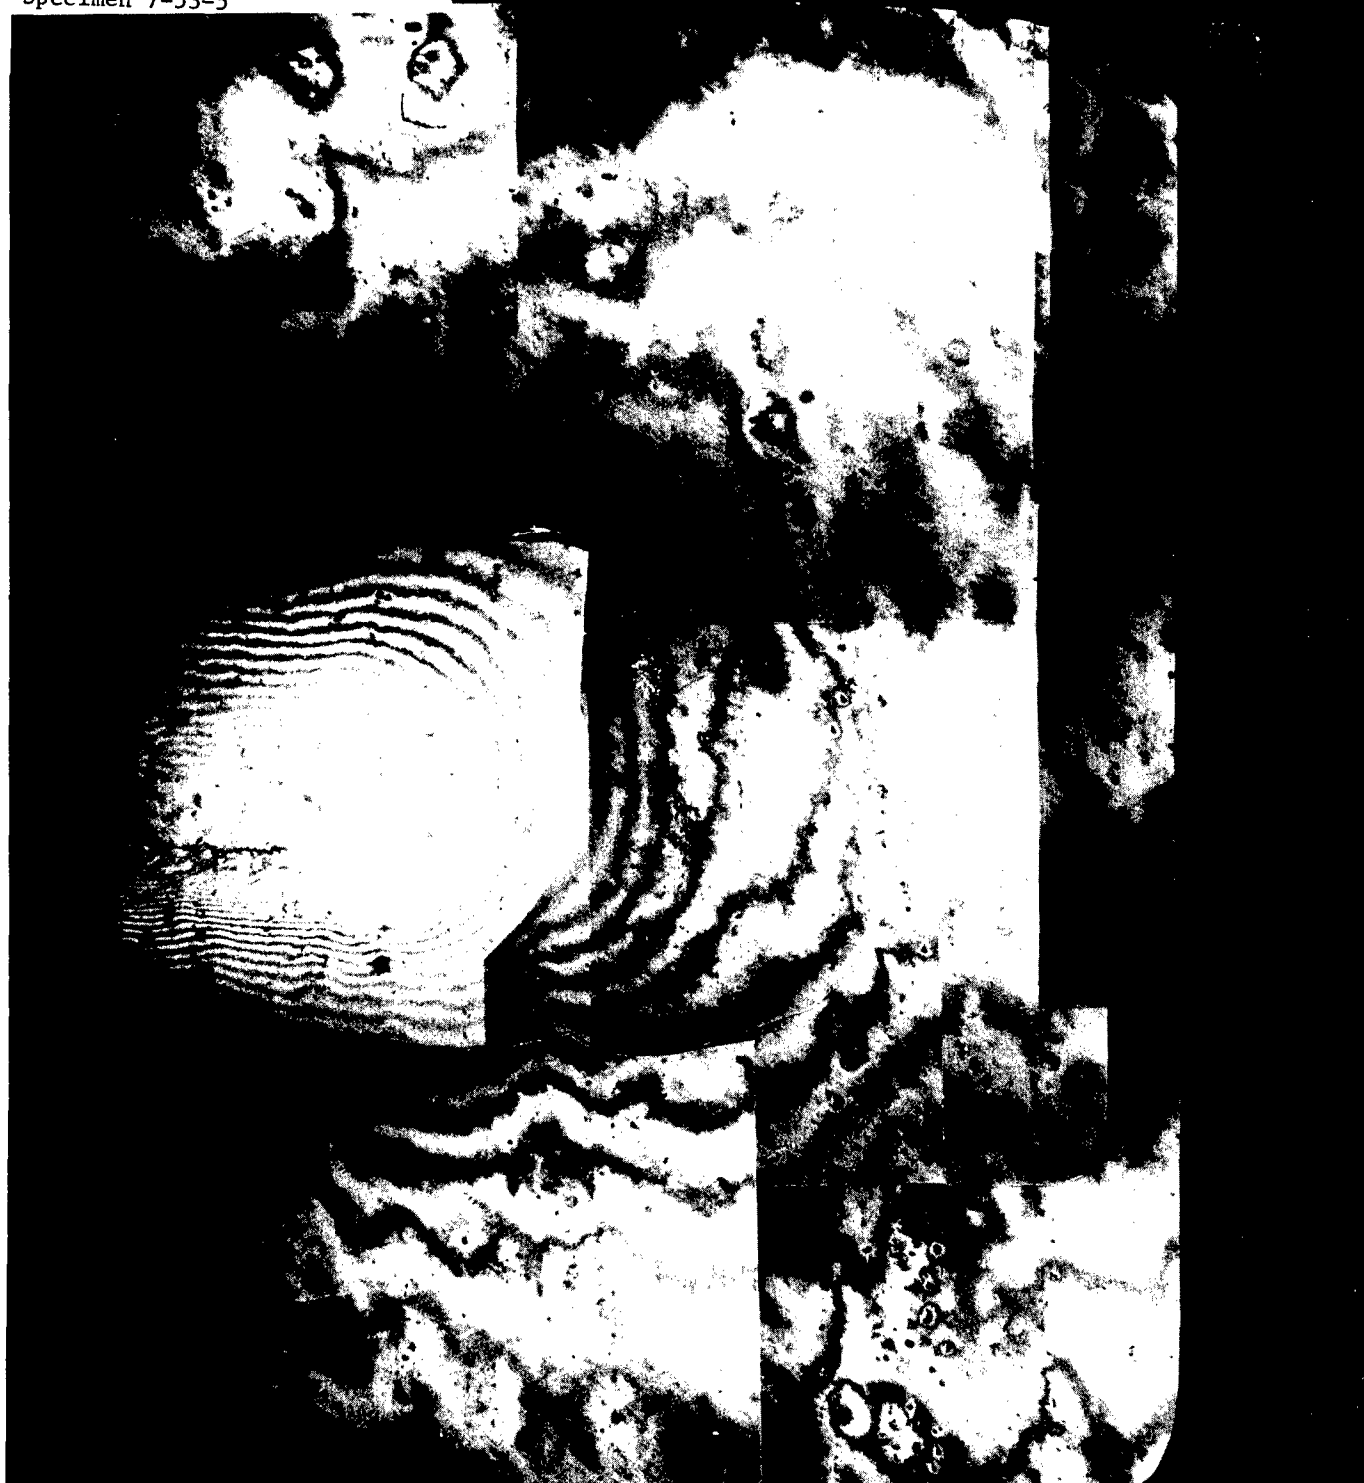
Figure 109. Interferometry Photograph of a Crack Unloaded from a Single Overload in a 7075-T7351 Specimen

7075-T7351,  $a = 1.01$  inch  
 $\sigma_x = -6.0$ ,  $\sigma_y = 12$  ksi unloaded  
Magnification: 47.5X  
Test Case 105  
Specimen 7-53-5

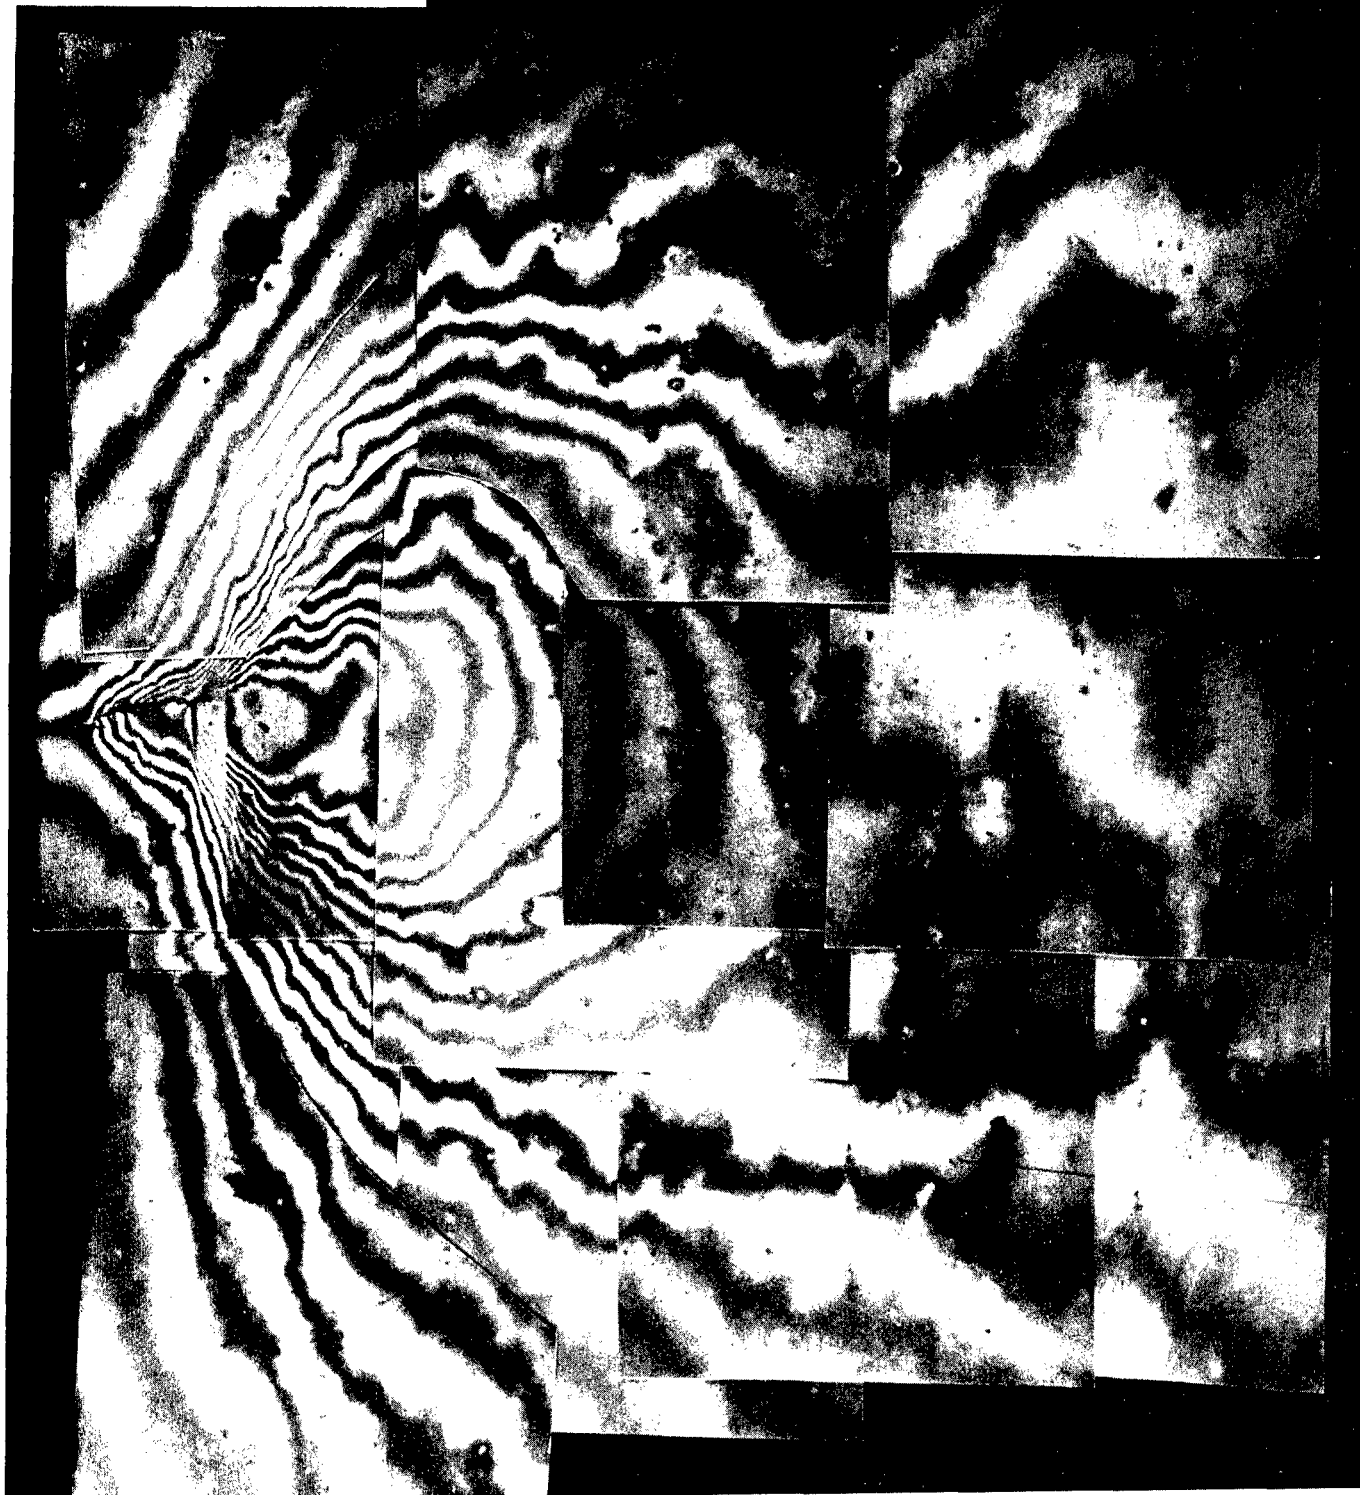
Figure 112. Interferometry Photograph of an Unloaded Crack  
in a 2024-T351 Specimen

2024-T351,  $a = 0.26$  inch  
 $\sigma_x = 0$ ,  $\sigma_y = 20$  ksi overloaded  
Magnification: 70.3X  
Test Case 101  
Specimen 2-24-2

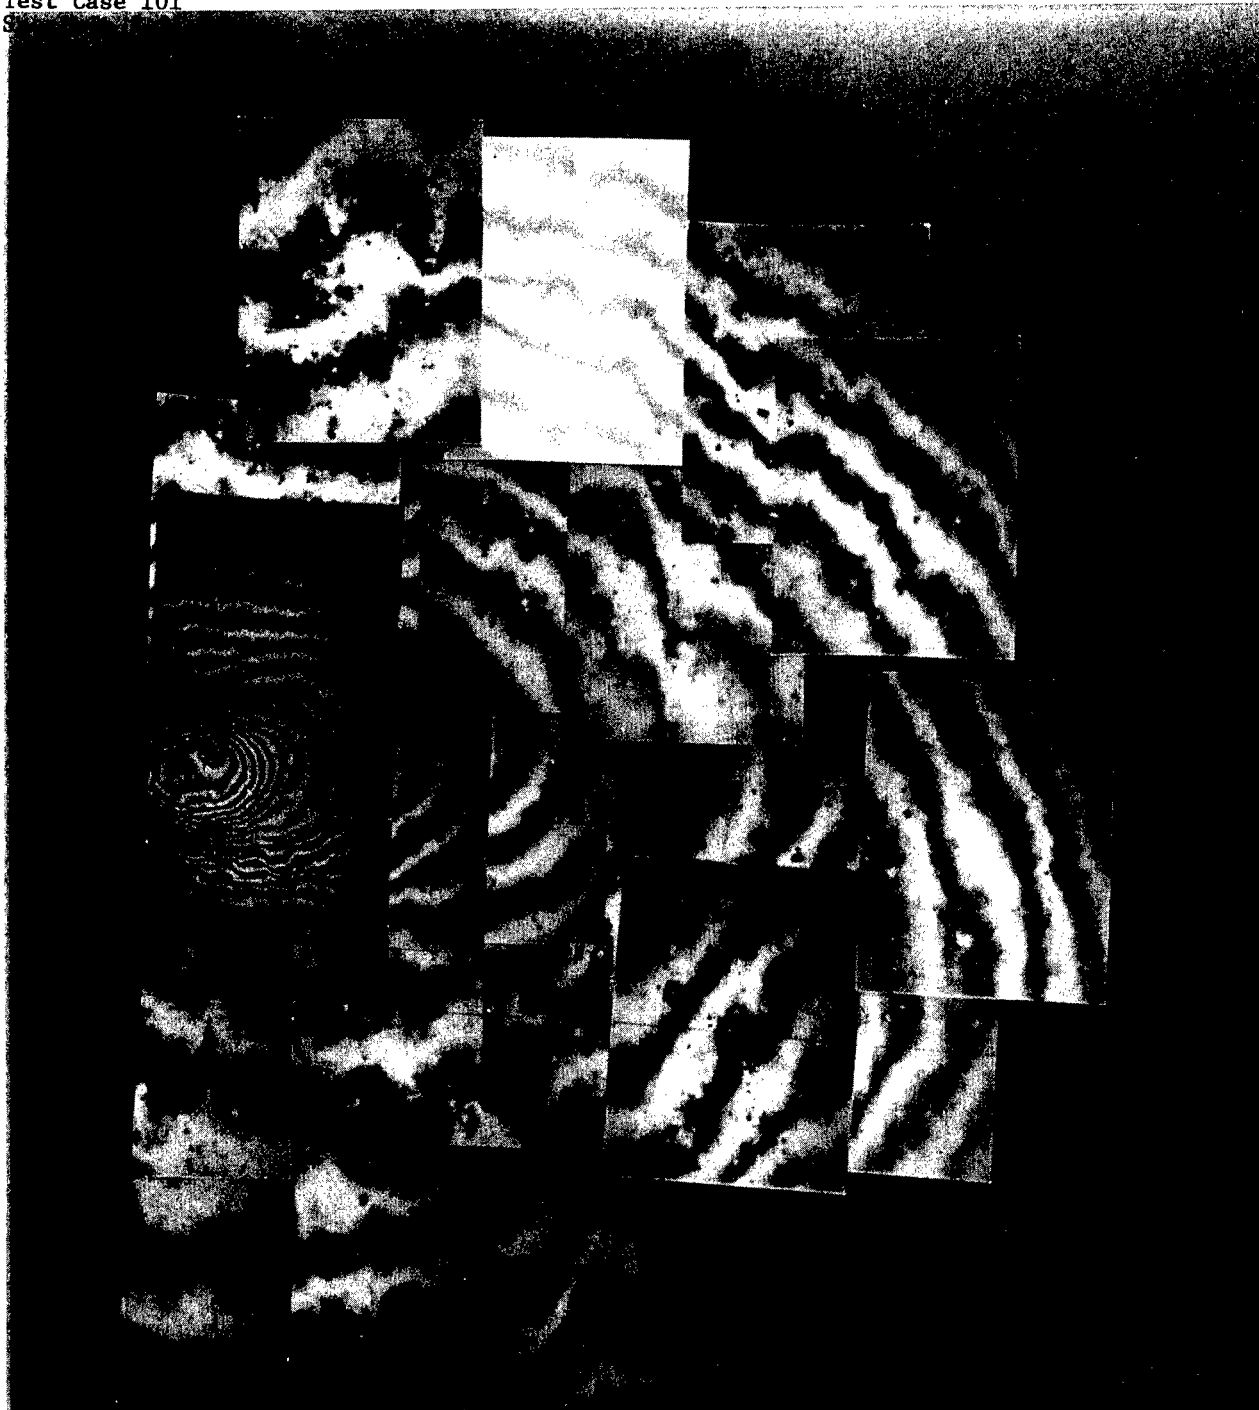
Figure 113. Interferometry Photograph of a Crack Unloaded from a Single Overload in a 2024-T351 Specimen

2024-T351,  $a = 0.49$  inch  
 $\sigma_x = 0$ ,  $\sigma_y = 10$  ksi unloaded  
Magnification: 35.9X  
Test Case 101

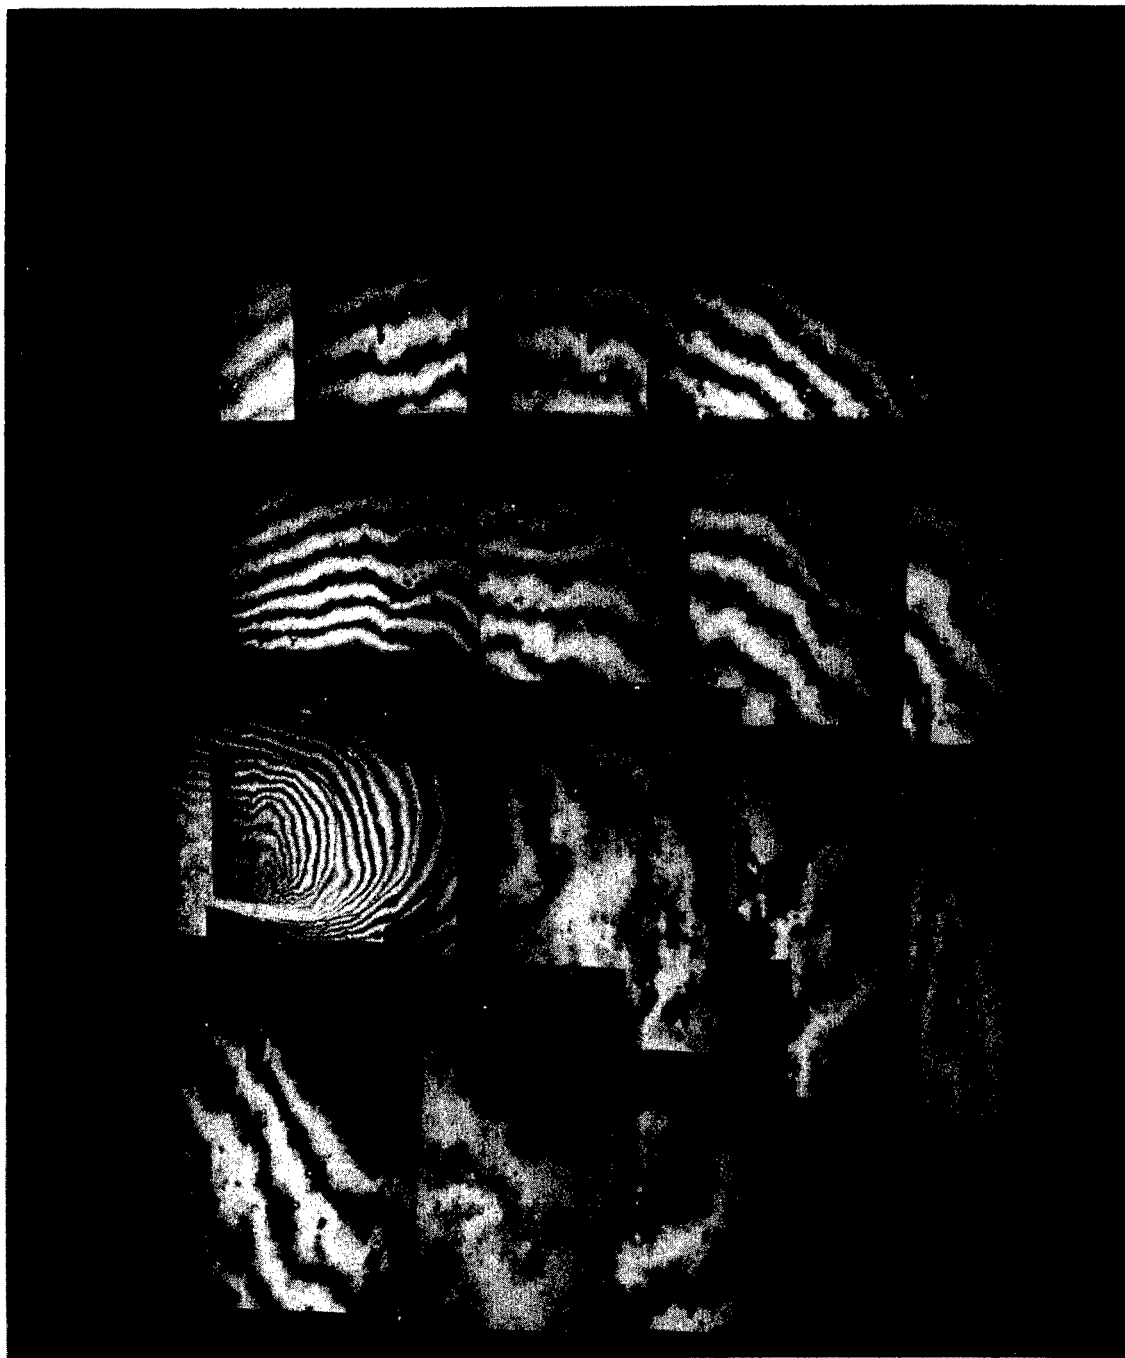
Figure 115. Interferometry Photograph of a Crack Unloaded from a Single Overload in a 2024-T351 Specimen

2024-T351,  $a = 0.93$  inch  
 $\sigma_x = 0$ ,  $\sigma_y = 10$  ksi unloaded  
Magnification: 22.5X  
Test Case 101  
Specimen 2-24-5

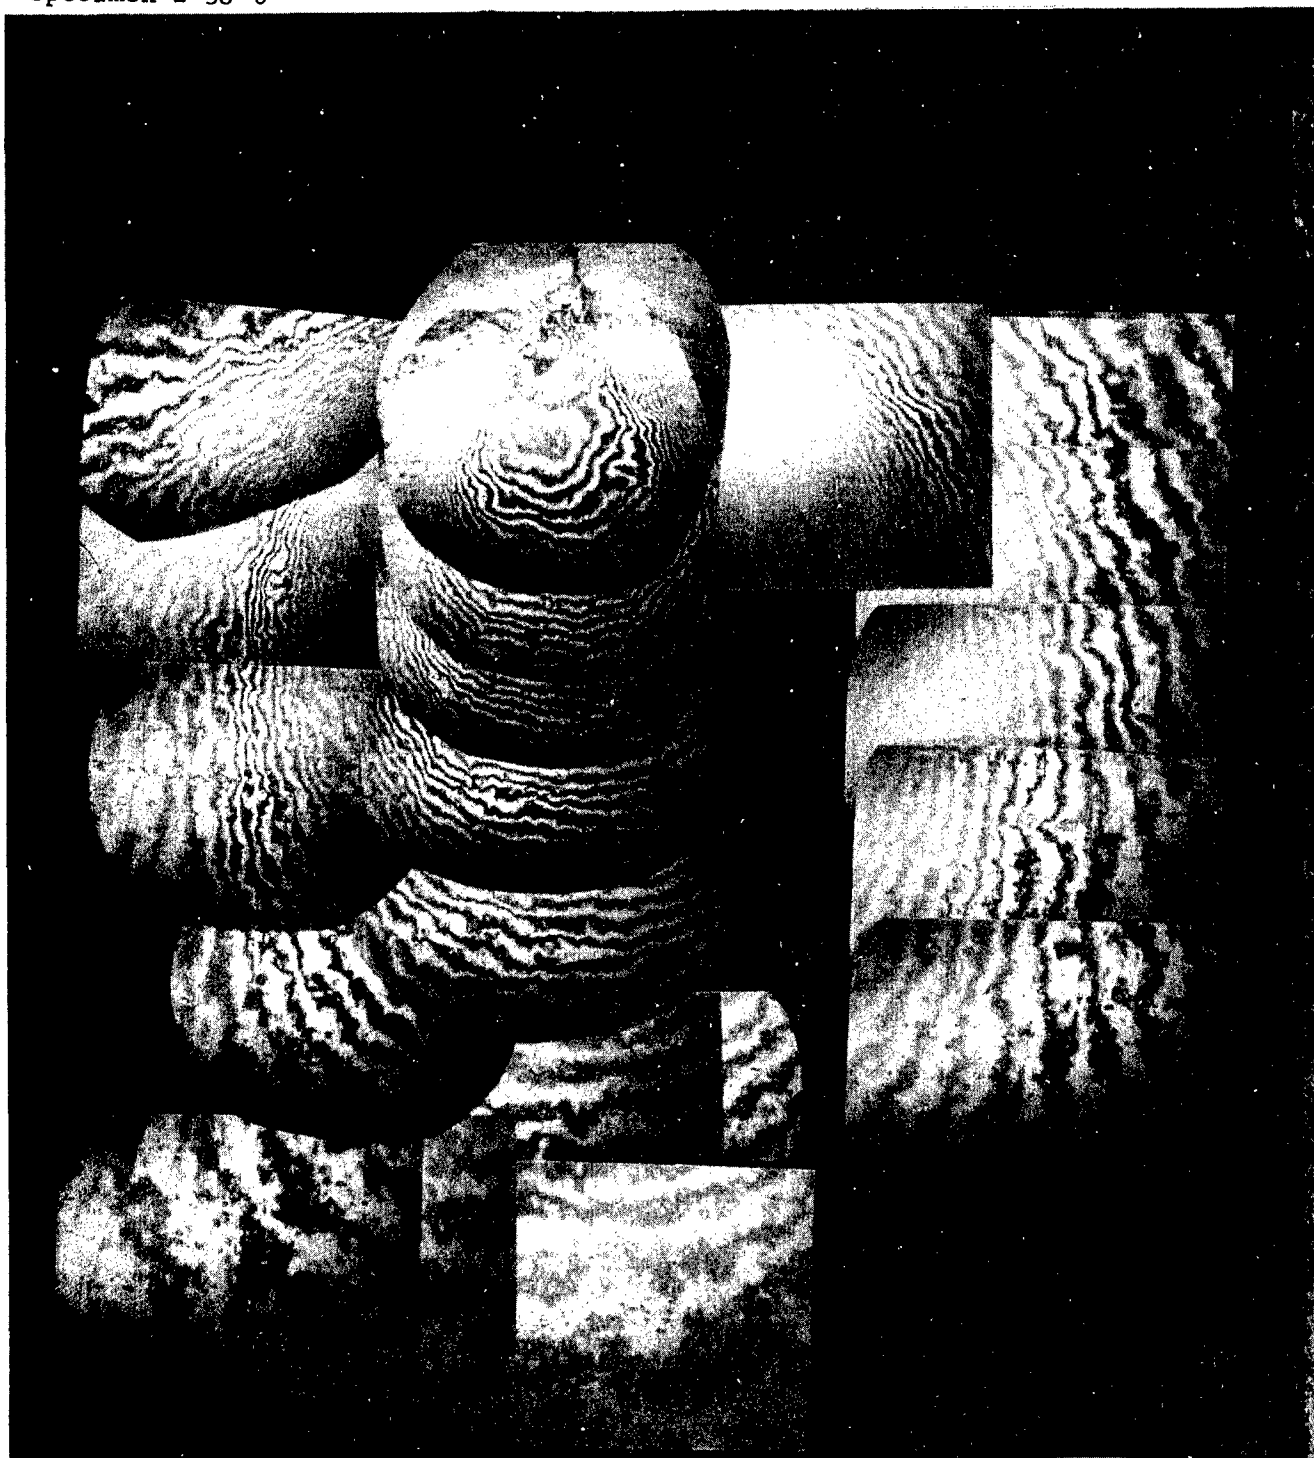
Figure 121. Interferometry Photograph of an Unloaded Crack in a 2024-T351 Specimen

2024-T351,  $a = 0.975$  inch  
 $\sigma_x = 10$ ,  $\sigma_y = 20$  ksi overloaded  
Magnification: 22.8X  
Test Case No. 108  
Specimen 2-38-6

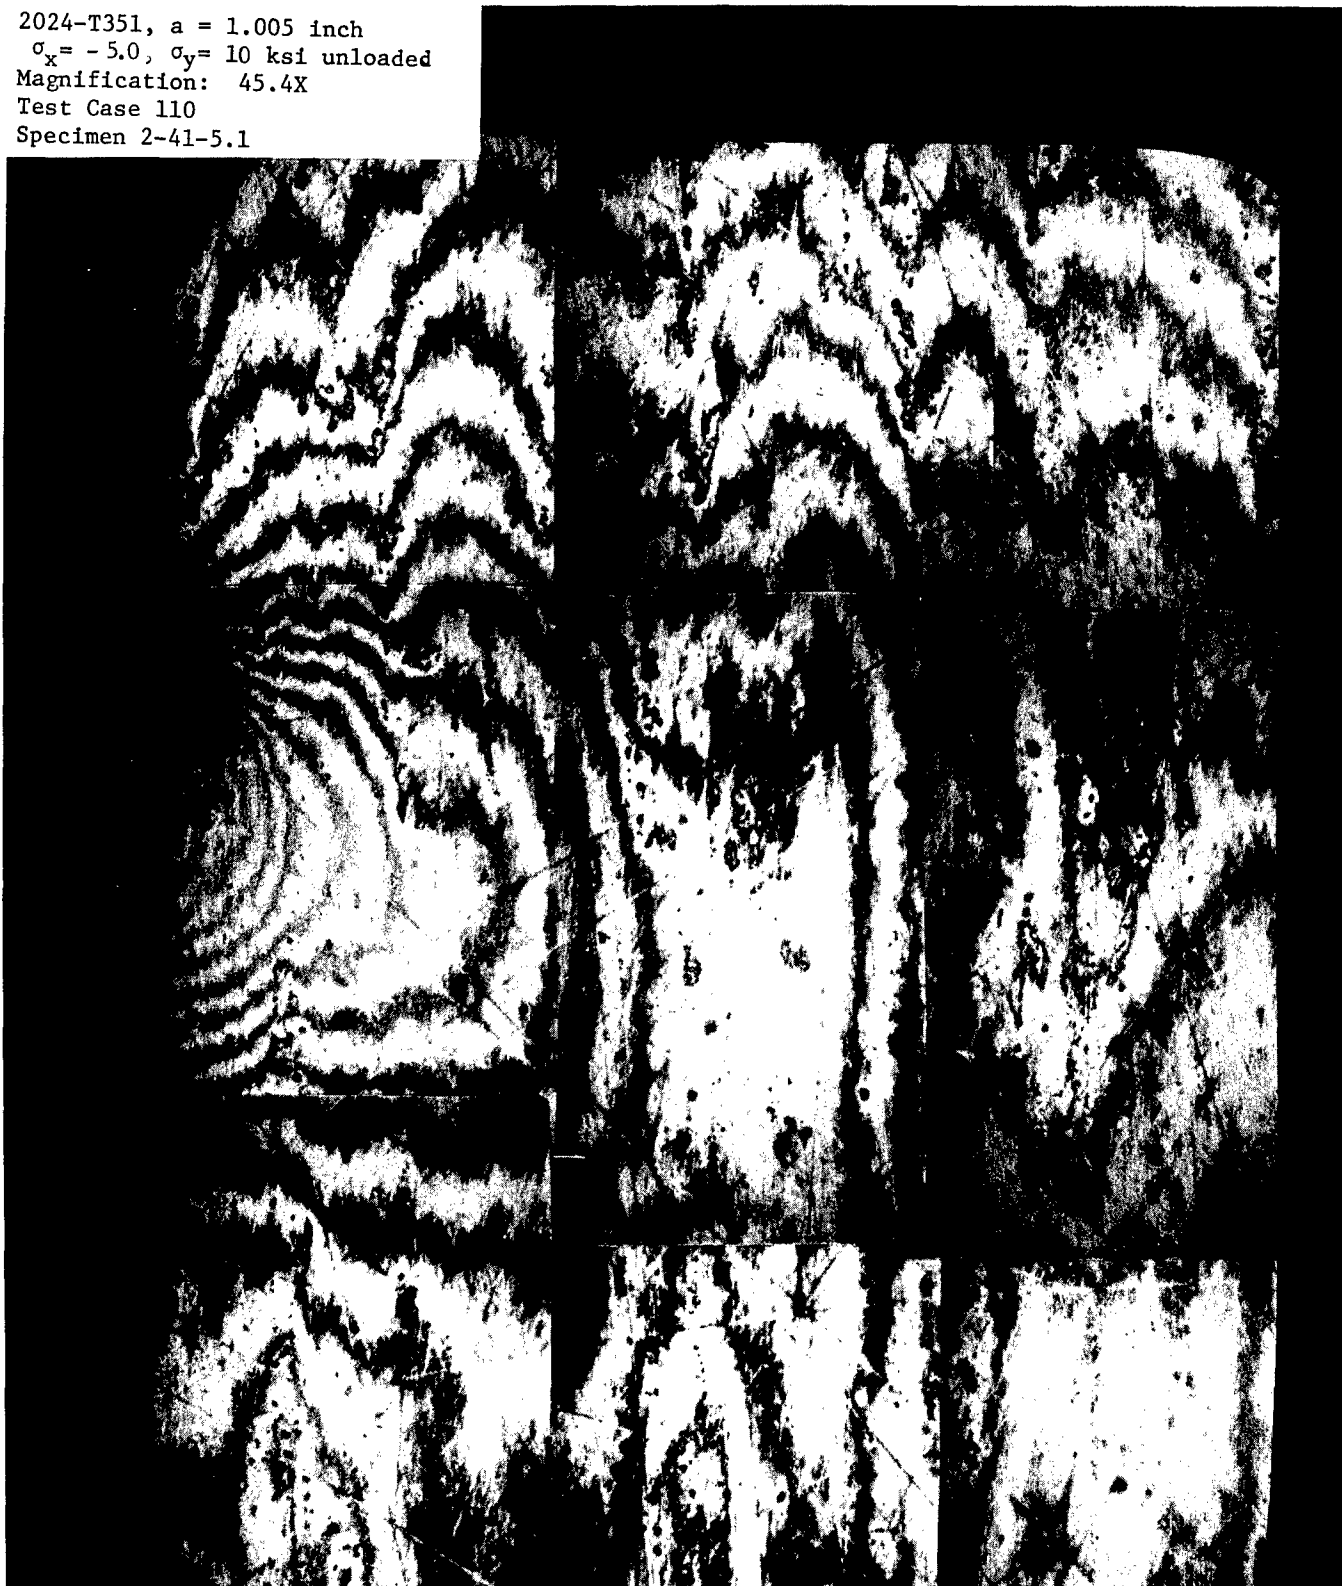
Figure 127. Interferometry Photograph of a Crack Unloaded from a Single Overload in a 2024-T351 Specimen

2024-T351,  $a = 1.005$  inch  
 $\sigma_x = -5.0$ ,  $\sigma_y = 10$  ksi unloaded  
Magnification: 45.4X  
Test Case 110  
Specimen 2-41-5.1

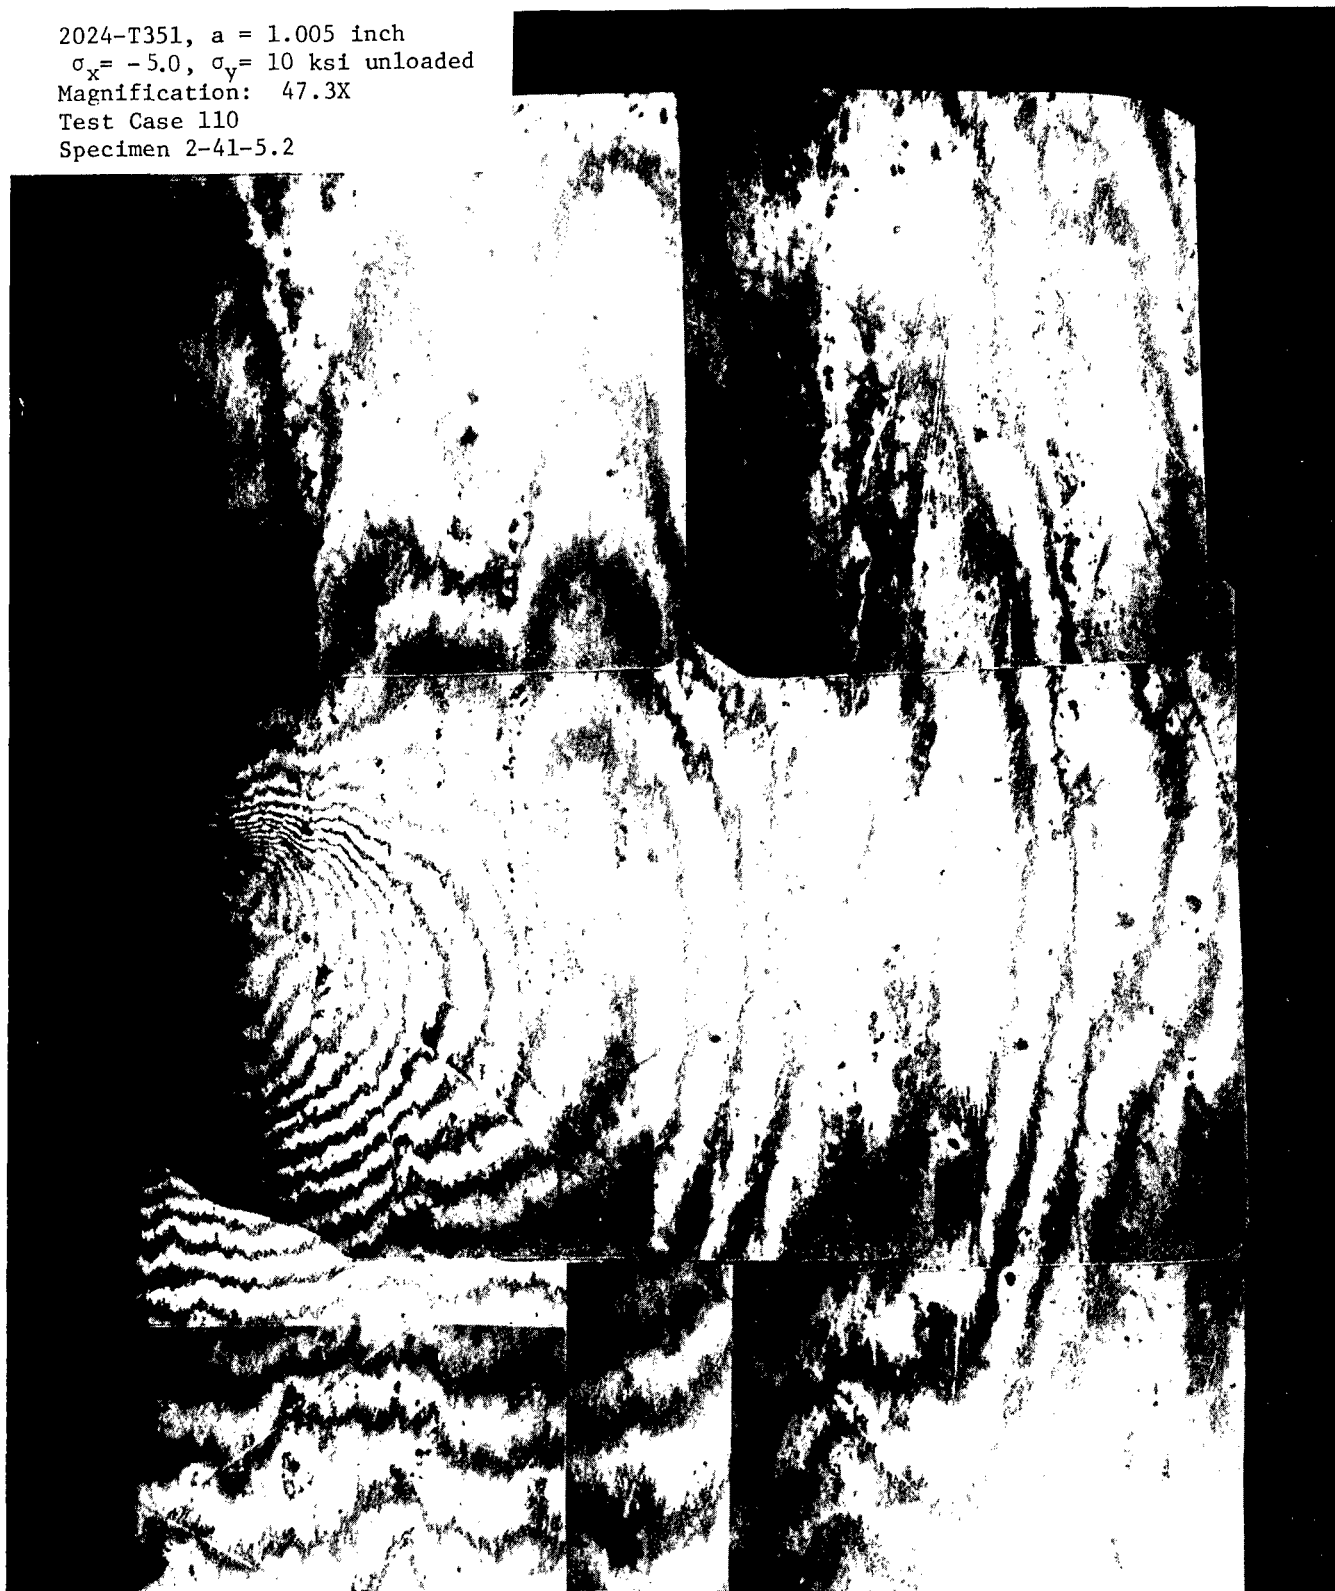
Figure 128. Interferometry Photograph of an Unloaded Crack in a 2024-T351 Specimen

2024-T351,  $a = 1.005$  inch  
 $\sigma_x = -5.0$ ,  $\sigma_y = 10$  ksi unloaded  
Magnification: 47.3X  
Test Case 110  
Specimen 2-41-5.2

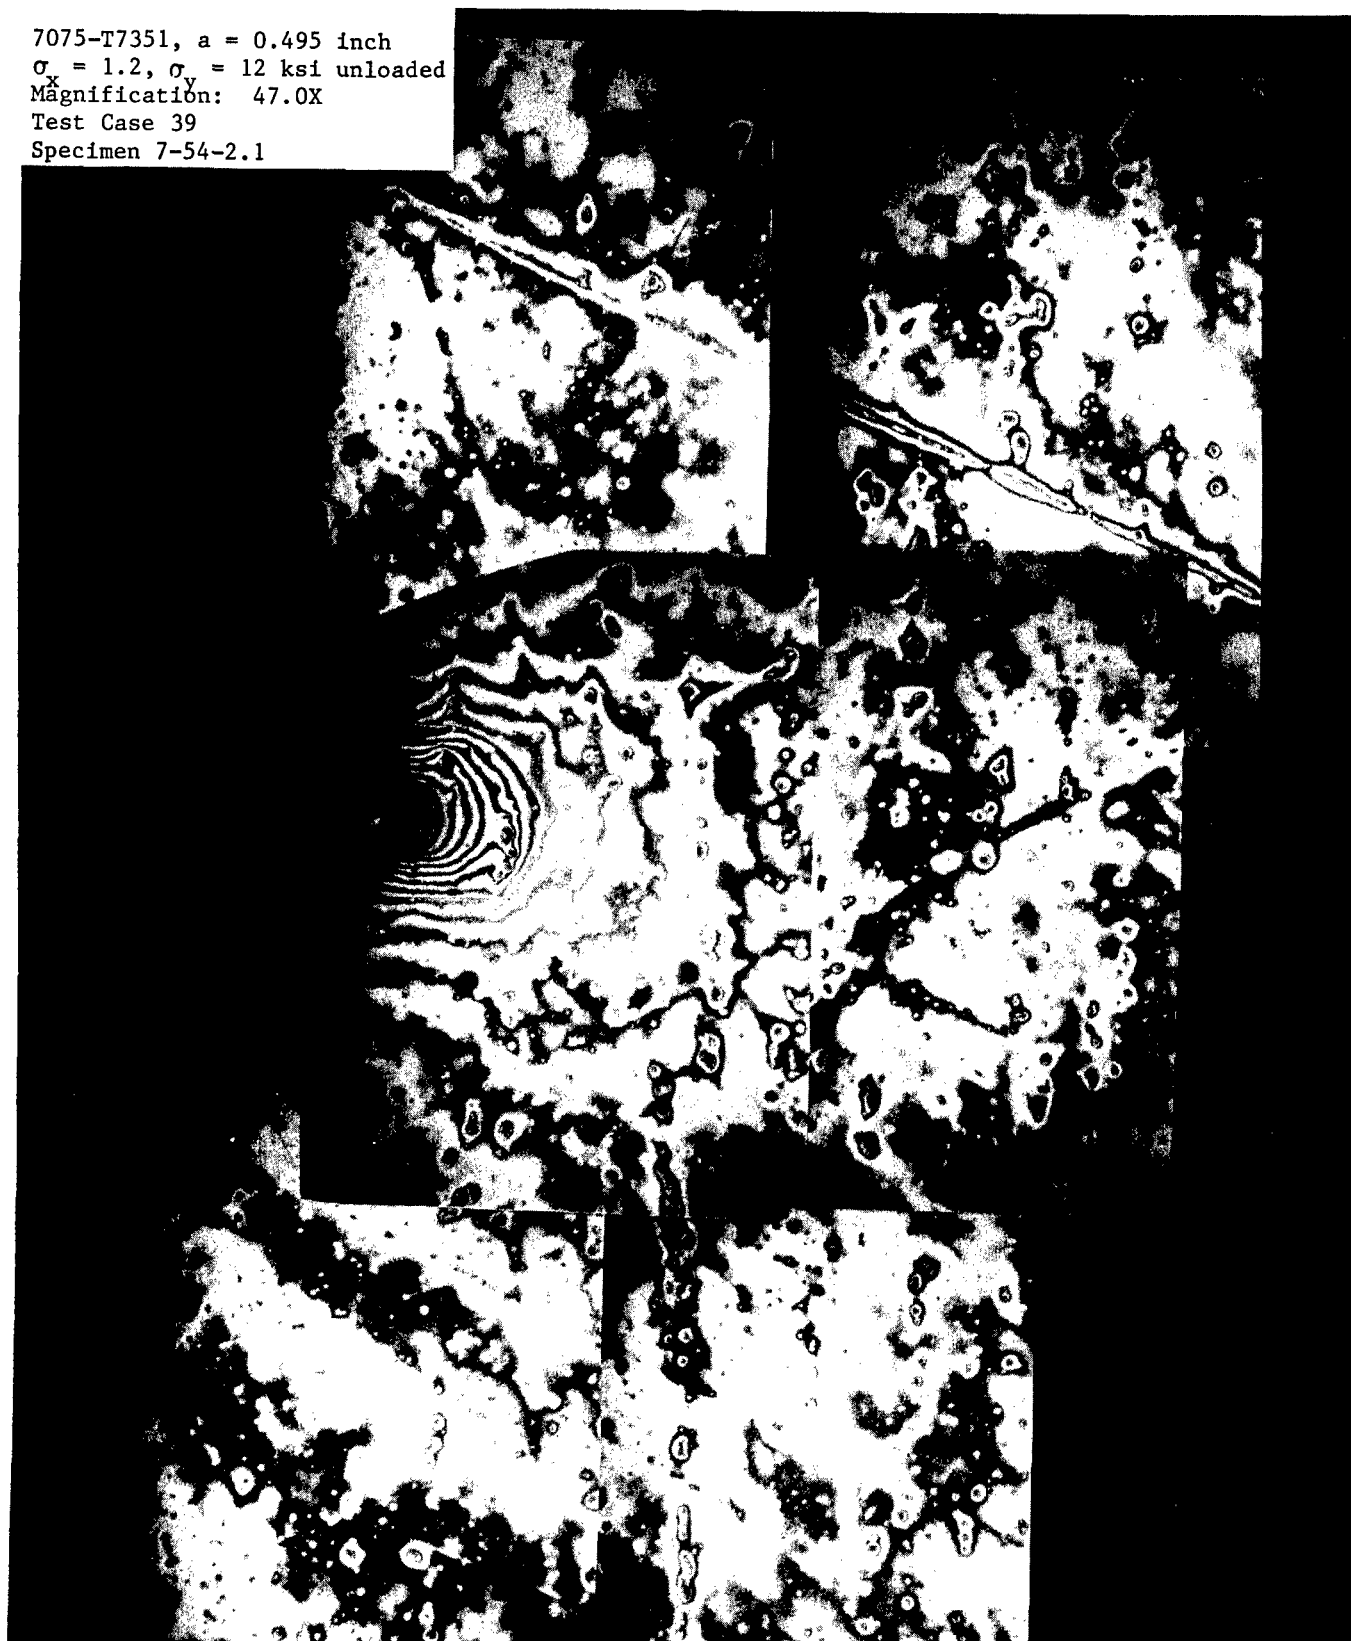
Figure 131. Interferometry Photograph  
of an Unloaded Crack in a  
7075-T7351 Specimen

7075-T7351,  $a = 0.495$  inch  
 $\sigma_x = 1.2$ ,  $\sigma_y = 12$  ksi unloaded  
Magnification: 47.0X  
Test Case 39  
Specimen 7-54-2.1

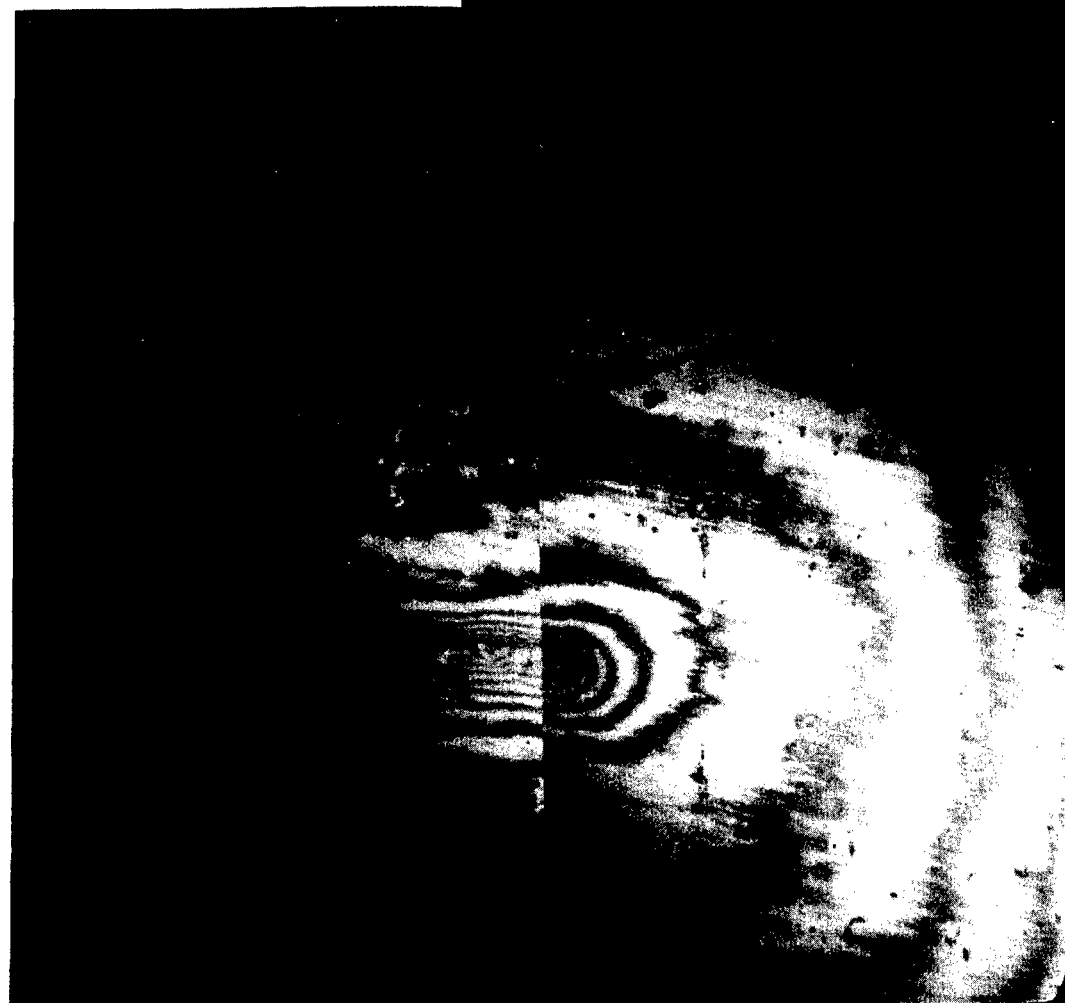
Figure 135. Interferometry Photograph of an Unloaded Crack in a 7075-T7351 Specimen

7075-T7351,  $a = 0.250$  inch  
 $c_x = .60$ ,  $\sigma_y = 12$  ksi unloaded  
Magnification: 48.9X  
Test Case 41  
Specimen 7-106-1
